# NOAA Abandoned Vessel Program

## Removal Case Study: *Samala*

Contributing Agency: Commonwealth of the Northern Mariana Islands – Coastal Resources Management

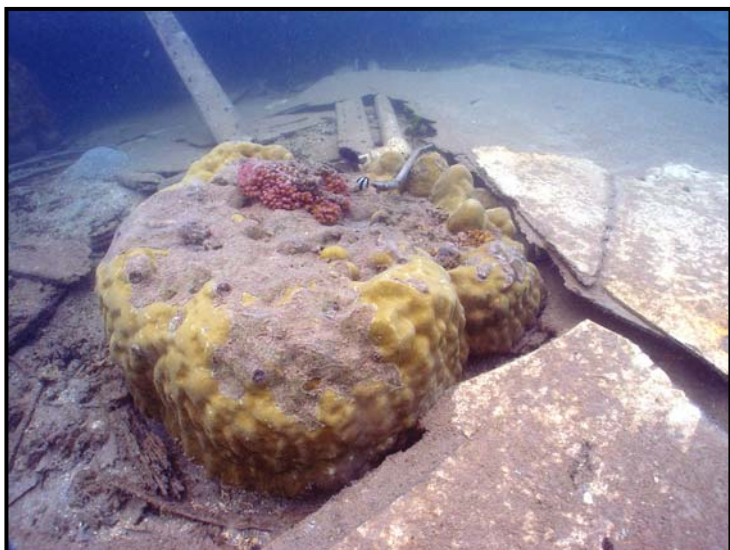
CMS & M began work in November 2004, after a series of two major typhoons and a tropical storm further battered the vessel and delayed operations. By the start of work, the hull and engine room had collapsed, creating a larger field of scattered debris. The seasonal tides had increased and the visibility had diminished substantially due to rougher seas. These factors resulted in additional man-hours for the removal, beyond those originally planned.

*Vessel debris on coral head*

There still are some remains of the Samala at the grounded site, including a large engine block and some smaller debris which will require removal in a second phase. Phase II is estimated to cost an additional \$15,000 to \$20,000. CRMO and DLNR have already begun to set aside funds for the final operation.

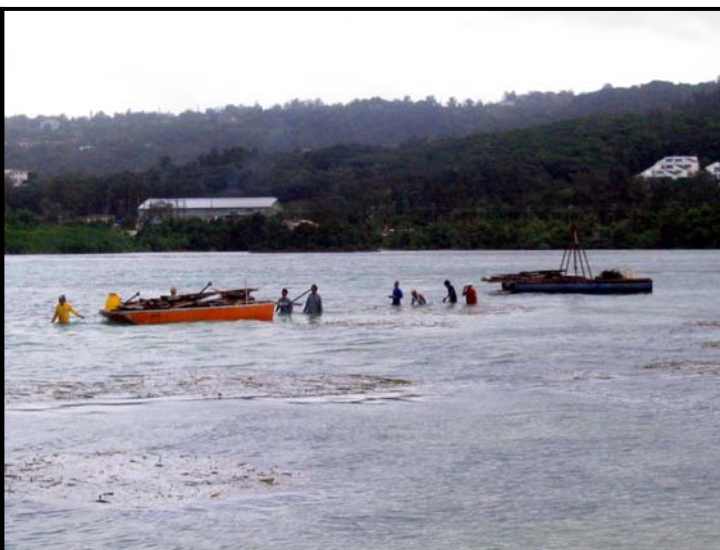
*Salvage crew on site*

A make-shift catamaran derrick barge was used in the water to lift heavy equipment, machinery, and metal pieces from the vessel. Fuel tanks and other diving apparatus were also removed without incident. At least 35 metric tons of heavy equipment and machinery and another 10 metric tons of smaller debris were salvaged. A small boat was used to transport the salvaged material to shore. Once near shore a boom truck off-loaded the material onto a flatbed that transported the salvaged material to an off-site staging area, owned by the contractor, for separation. Metal was taken to a scrap yard for eventual recycling off island, while the remaining debris is being processed for further recycling before final disposal in the Saipan Marpi Landfill.

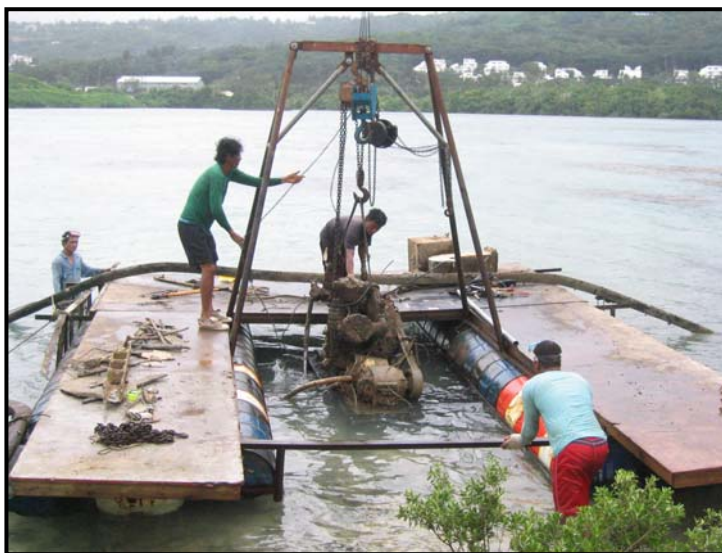
*Debris retrieval*

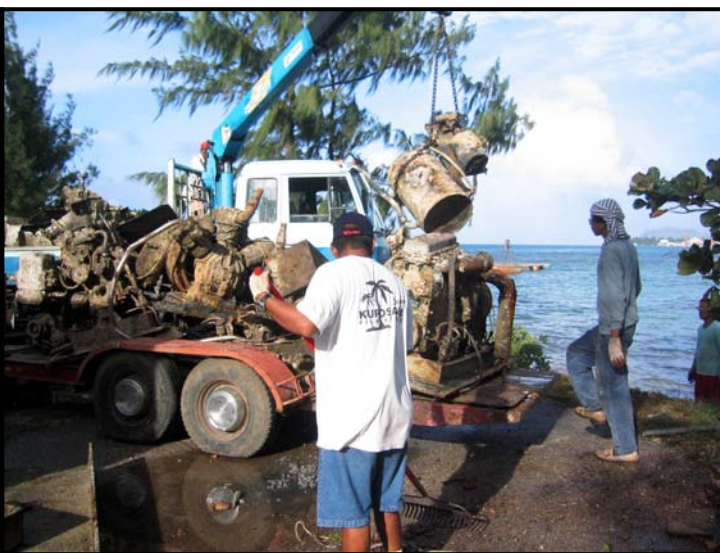
*Loading truck for off site transport*

All metal was separated and sent off island for recycling. The remaining material is still being processed by the salvage company before final disposal at Saipan's Marpi Landfill.
